**TAMARACK LAKE DAM "B"**

NDI No. PA 00746

May 1979

PHASE I INSPECTION REPORT  
NATIONAL DAM INSPECTION PROGRAM

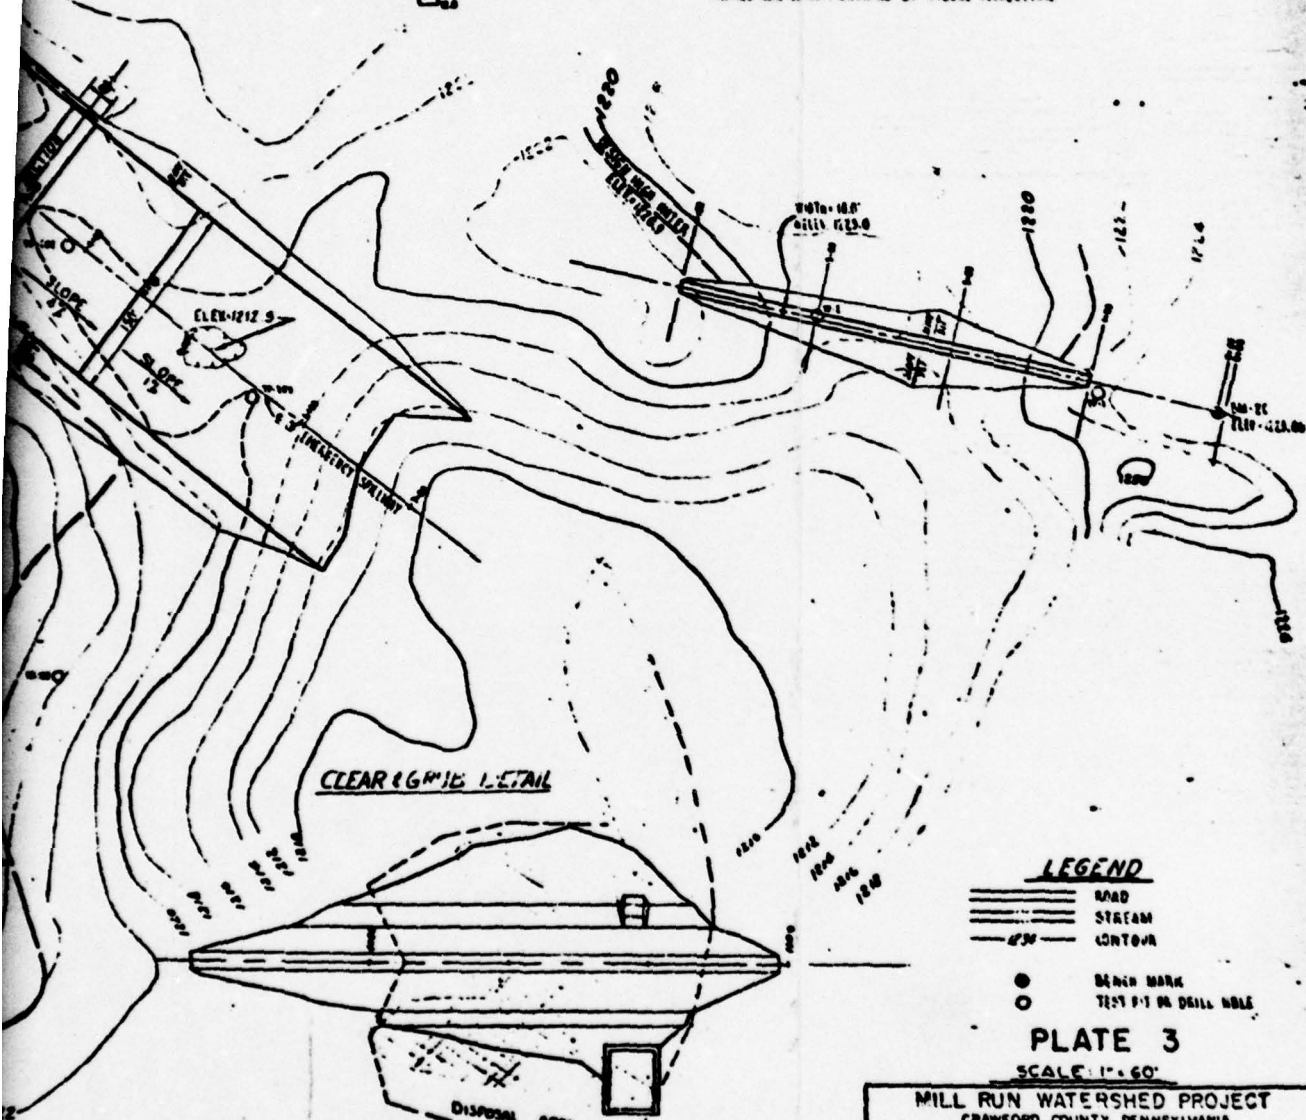
**PLATE 3**

GEOLOGIC INVESTIGATION DATE - NOV. '64  
UNIFIED SOIL CLASSIFICATIONS BY VISUAL INSPECTION

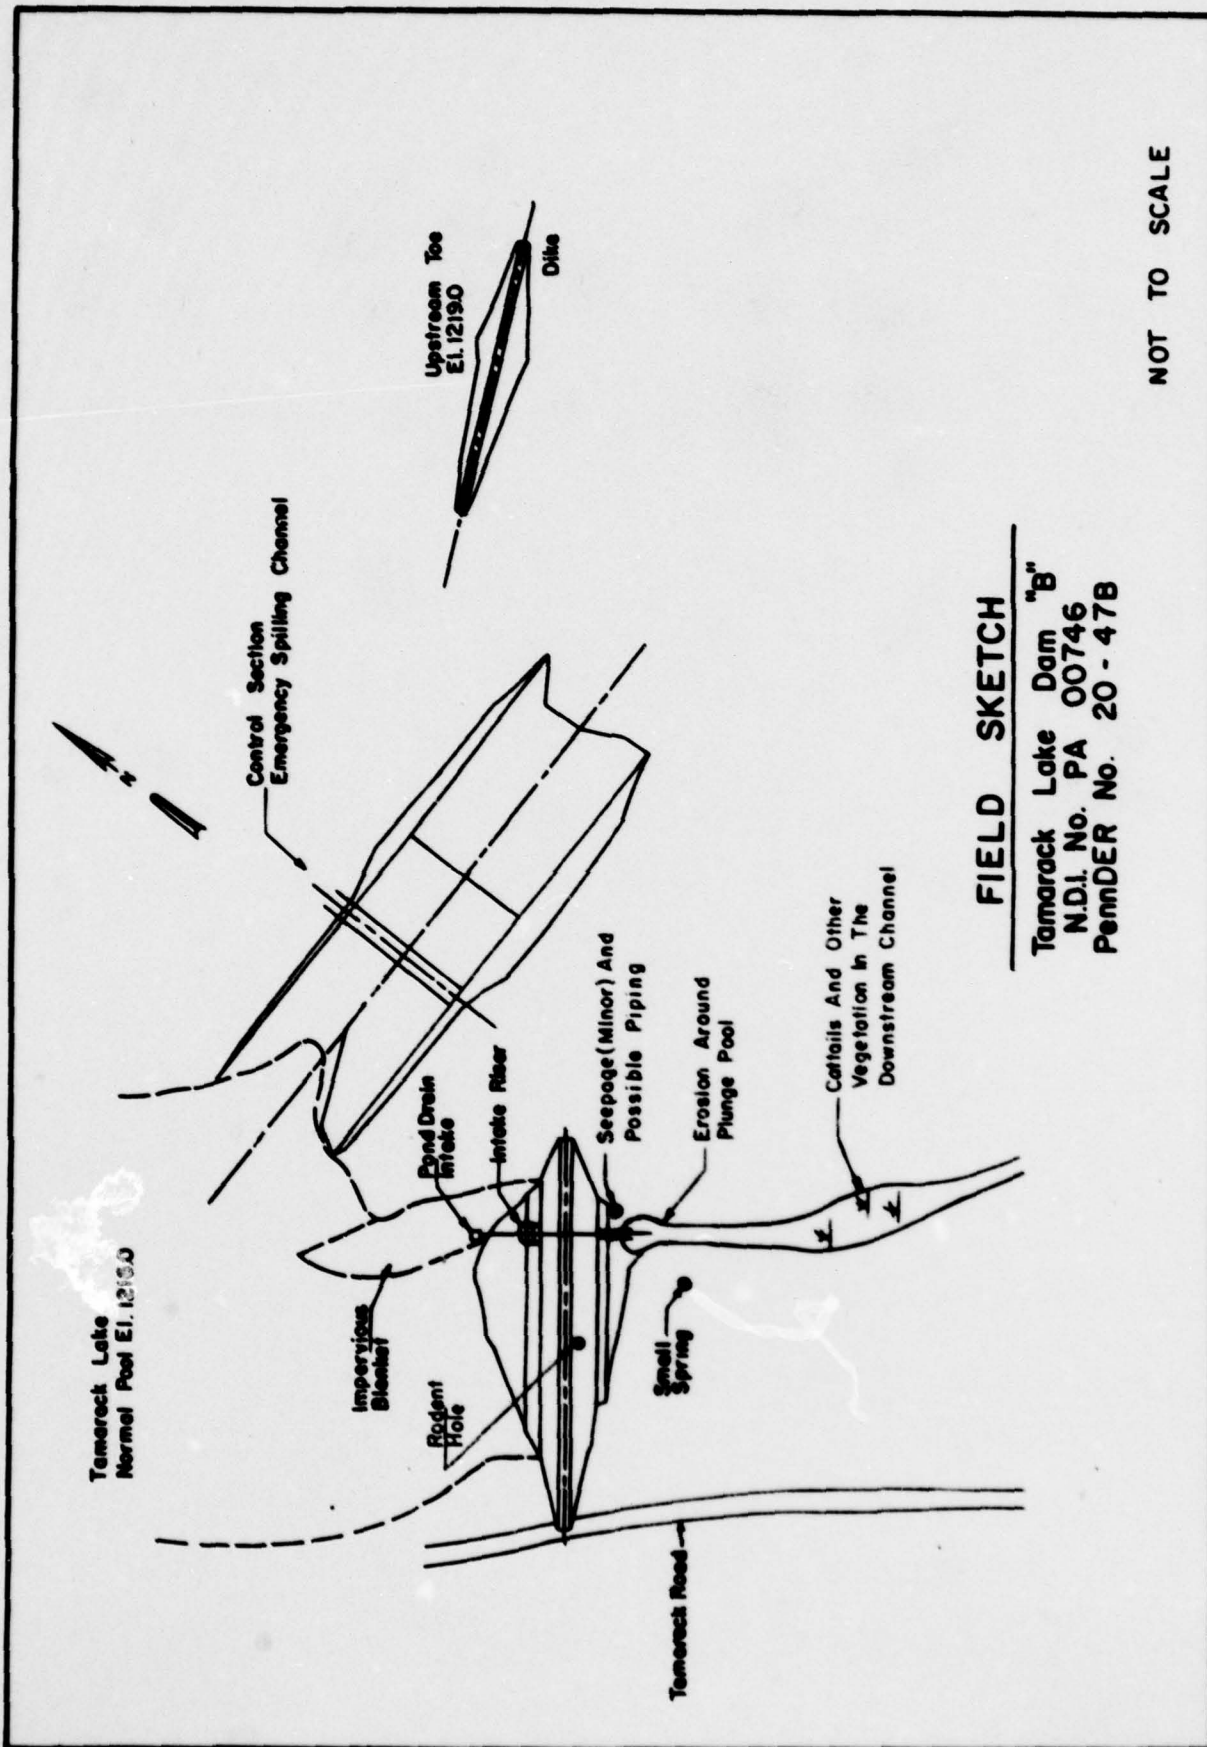
# FIELD SKETCH

VISUAL EXAMINATION OF	OBSERVATIONS	REMARKS OR RECOMMENDATIONS
CONDITION (OBSTRUCTIONS, DEBRIS, ETC.)	No serious erosion or debris was noted in the downstream channel. There is, however, some vegetation located in the channel just below the stilling basin.	The downstream channel should be checked periodically for debris or other obstructions. The vegetation should be removed from the channel immediately downstream of the outlet pipe to minimize restriction of flood flows.
SLOPES	The slope of the downstream channel is mild, averaging approximately 0.3% from the dam to the confluence with Little Sugar Creek.	
APPROXIMATE NO. OF HOMES AND POPULATION	There are only a few homes located between the dam and the confluence of Mud Run and Little Sugar Creek, a distance of approximately 1.5 mi. The Little Sugar Creek floodplain is relatively uninhabited along its approximately 6.5 mi. course to the Borough of Cochranton.
